NASA TN D-4235

EFFECT OF COVER GAS PRESSURES ON ACCELERATED CAVITATION DAMAGE IN SODIUM

by Stanley G. Young and James R. Johnston

*Lewis Research Center
Cleveland, Ohio*

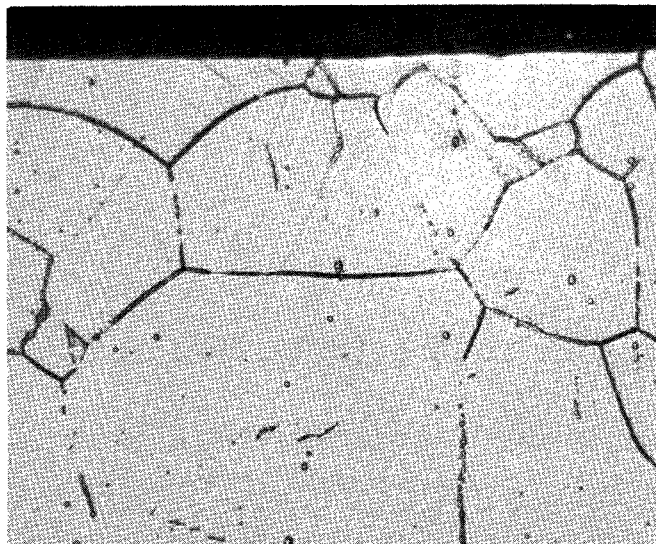
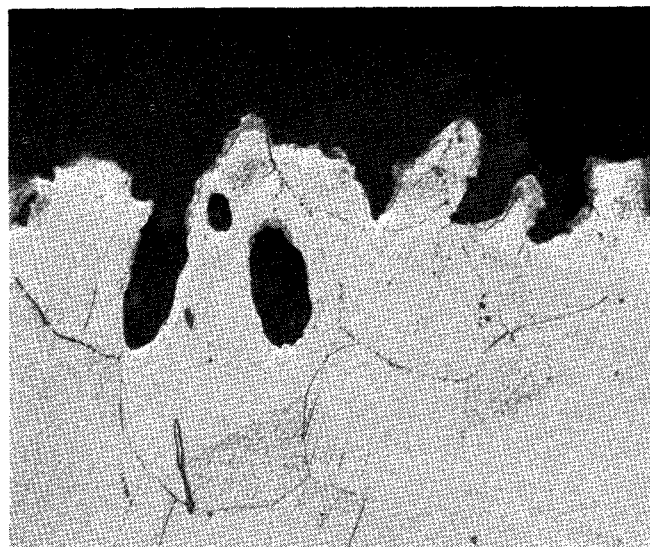
As-received, X500.

240-Minute exposure at 1 atmosphere, X500.

240-Minute exposure at 4 atmospheres, X500.
(b) AISI 316 stainless steel.

Figure 13 shows photomicrographs of sectioned specimens of all materials before and after testing. All the materials tested exhibited gross undercutting and transgranular cracking. Evidence of subsurface deformation existed in the form of slip bands for all materials. Bending of twin boundaries was observed in L-605 (fig. 13(a)). Breaking of subsurface carbides in Stellite 6B is apparent in figure 13(c). No evidence of any reaction zone was found in the cavitation damaged regions of any specimen.
